# Manhole Inspection Summary

Manhole # S31I2007MH

**Location** Address: **6219 MOSSWAY**

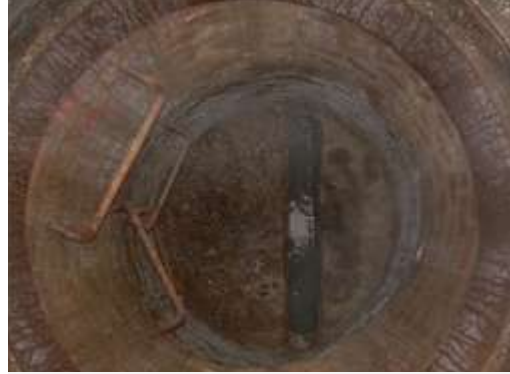
Top View

Corroded steps. Bench debris.

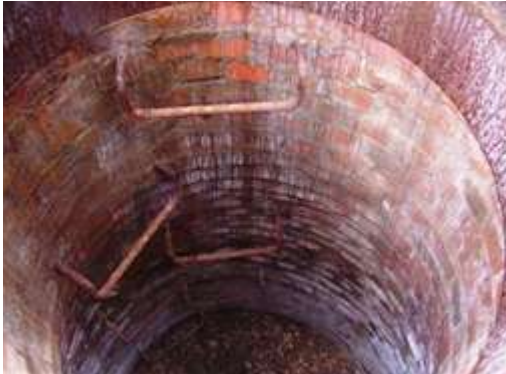
Defect

Adjustment deterioration and infiltration.  
Corbel and Barrel infiltration.

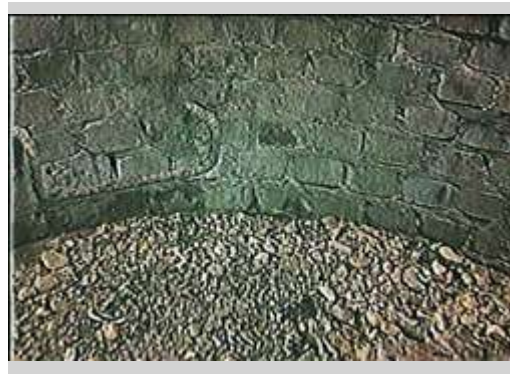
Defect

Barrel deterioration and infiltration. Bench  
debris.

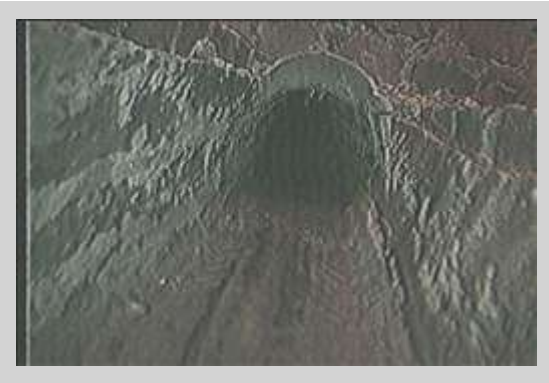
### 8 in. Circular Gravity Sewer Pipe Out @ 12 O'Clock

Barrel deterioration.

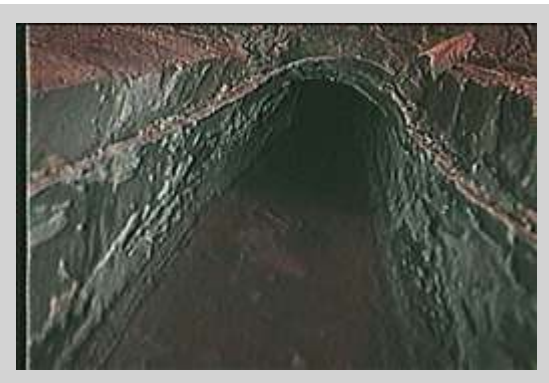
### 8 in. Circular Gravity Sewer Pipe In @ 6 O'Clock

Deposits: ☐ None ☒ **Mud** ☐ Sludge ☒ **Debris** ☐ Grease

Silt Depth: **0.5** (in.) Deposits Extent: **Light**

Infiltration: **Evidence** Pipe Seal Cond: **Unknown**
